**“Riveting Reading”
North Carolina Wing
Aircraft Maintenance**

Jan 1, '19. Vol #13
By Major Martin 'Stryker' Heller

N358CP receives repaired engine & home.

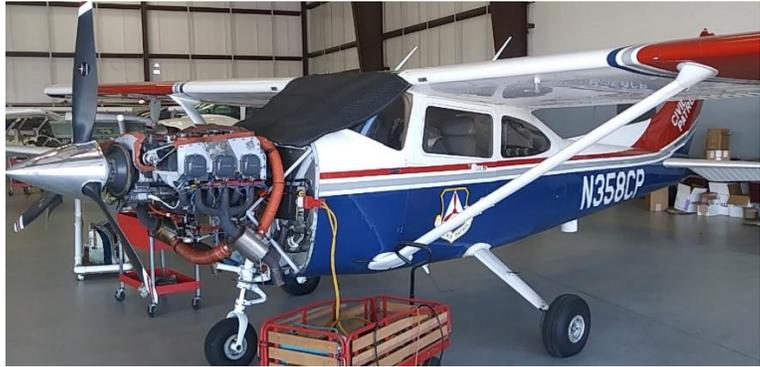
The big news is N358CP (MESA), picture above, had its engine "repaired." It also is getting a new home; in Utah. The Rocky Mountain Region needed several planes, and N358CP was traded for a future new NCWG aircraft. While flying to break in the new cylinders, we didn't hear the autopilot disconnect warning. Turns out it wasn't hook up. Wonder how long that was a problem. Its back on line now, going to Raleigh soon, and then west.
