**“Riveting Reading”
North Carolina Wing
Aircraft Maintenance**

Feb 1, '19. Vol #15
By Major Martin 'Strvker' Heller

NCWG Status on Champion Slick Magneto Service Bulletin SB11-15A

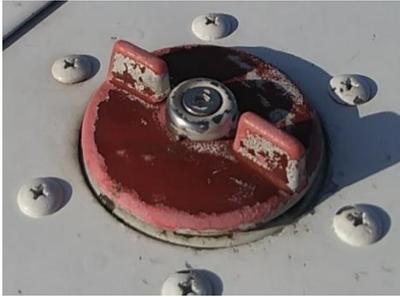
4. Trivia Time: This month's topic – Refueling

A. Why does the fuel cap have the aluminum screw in the middle?

Fuel Answers: A. The middle center is for fuelers to ground the airplane by touching the tip of the nozzle (besides the grounding wire) before opening the cap to disperse fuel. (Per the Phillips 66 Aviation Professional Linemen's Training Course.) Don't ask me other than Cessna gas caps don't have it. Answer B. (Hint, its in the chemical warning sign).

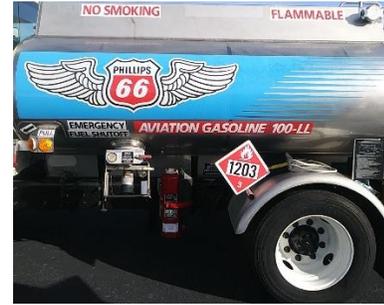
B. How can 100LL trucks help you avoid an embarrassing phone call? Answers below:
