**“Riveting Reading”**

**Civil Air Patrol  
North Carolina Wing  
Aircraft Maintenance**

**Mar 1, '20. Vol #28**  
*By Major Martin ‘Stryker’ Heller*

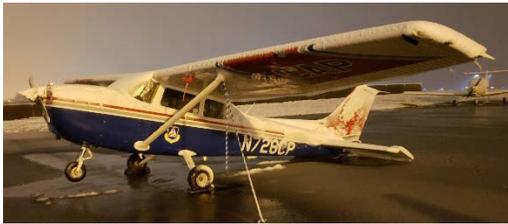
**3g. No Biz, like Snow Biz:** (Lesson Learned) The 20 Feb storm dropped a few inches of wet (read: Heavy) snow at KRDU. The extra weight put N726CP on its tail. Yes, the new elevator did touch the ground, but the tie-down ring took most of the hit. **Capt Don Williams, NC-048/DO**, responded to the FBO call, cleaned off 'Betty's' tail and put cushioning (milk crate & foam) on the tail tie-down ring in case it happened again. (Photos below). He also moved as much weight from the baggage area to the front seat floorboards as possible. That 40# shift moved the CG forward ~2.5 inches, requiring much more weight on the tail to topple it again. FYI: The newer C-172R & S models are more tail heavy than the C-172P because of avionics aft of the baggage area. Besides the weight shift, all crew chiefs might want to test what they have for tail stands, whether milk crates, traffic cones, the onboard fuel ladder, or a combination of stuff. Ideas are welcome and we'll pass them along.
