“Riveting Reading” North Carolina Wing Aircraft Maintenance

Nov 1, '18. Ed #11

By Major Martin 'Stryker' Heller

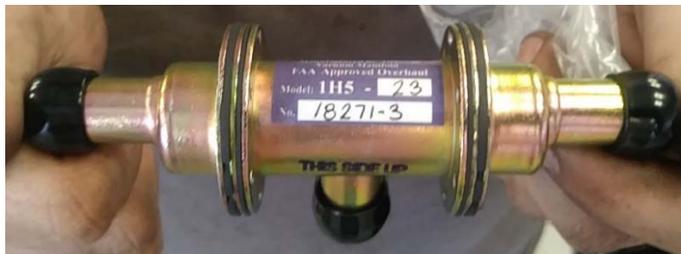
This is N99832's vacuum manifold; basically, a pneumatic T-valve. After 33-years, the rubber seals gave, and needed to be replaced; a lot cheaper to rebuild than to buy new. To move the aircraft, the backup vacuum was bypassed (IFR restricted). The part was returned/re-installed in late October.
